# TMS320F2837xS Real-Time MCUs Silicon Errata

## Silicon Revisions C, B

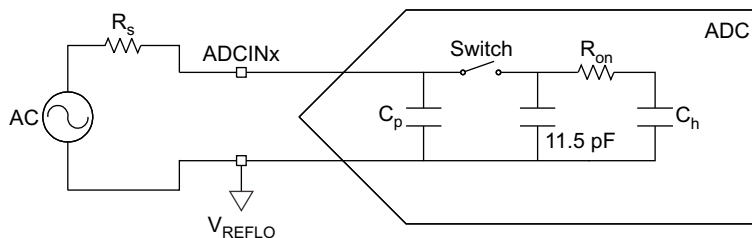
**Figure 4-1. Single-Ended Input Model**

The ADC input model should be used to select the sample-and-hold (S+H) duration for each ADC input. For the revisions affected, if the currently converting channel is an even-numbered channel and the previously converted channel was an odd-numbered channel (or vice versa), then the 12-bit input model will not accurately predict ADC input performance. Under these conditions, an additional capacitance should be added to the model. This capacitance has a value of 11.5 pF and should be placed between the S+H switch and  $R_{on}$  as shown in [Figure 4-1](#).
