IWR1843AOP Device Silicon Errata

Silicon Revision 1.0

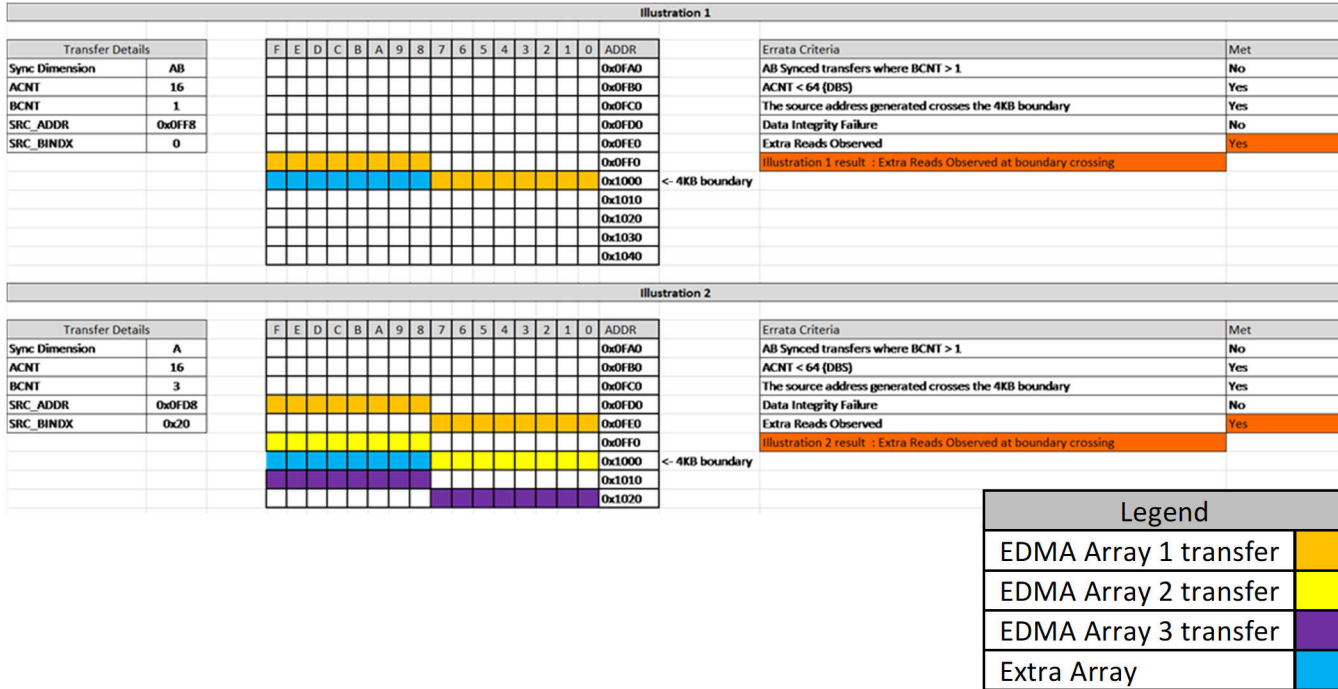
Figure 5-1. Scenario ID #3 – Extra Reads

For each extra read in **Scenario ID #3** for which **Condition [1]** is applicable, each index i above that satisfies the condition results in extra read from starting address SRC_ADDR + (i + 1) * SRCBIDX and of length equal to the distance from the start address to the boundary [that is, 0x1000 – X(i)]. Note: length < ACNT.

For **Scenario ID #3, Scenario ID #4, and Scenario ID #5**– EXTRA READS, another workaround besides avoiding the 4-KB boundary cross conditions, is to ensure that buffers involved in this kind of transfer are positioned so that extra reads stay within the physical memory boundaries. If the extra reads go to Reserved space or space blocked by the Memory Protection Unit (MPU), the TPTC generates a bus error interrupt to the processor.

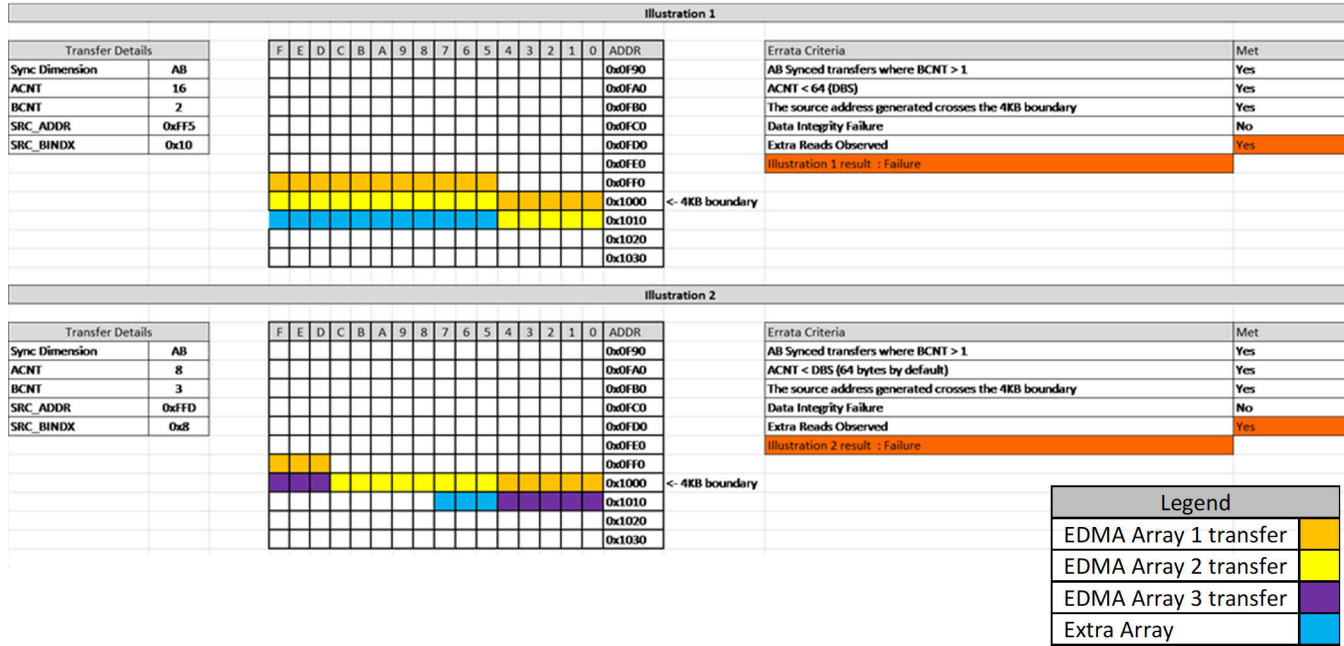
Figure 5-2. Scenario ID #4 – Extra Reads

For each extra read **Scenario ID #4** in for which **Condition [1]** is applicable, there is an extra read from starting address SRC + BCNT * ACNT (=SRCBIDX) of length equal to the distance of the start address to the boundary [that is, length is 0x1000 – X(i)], where i is the index of one and only 4-KB boundary crossing condition. Note: length < ACNT.

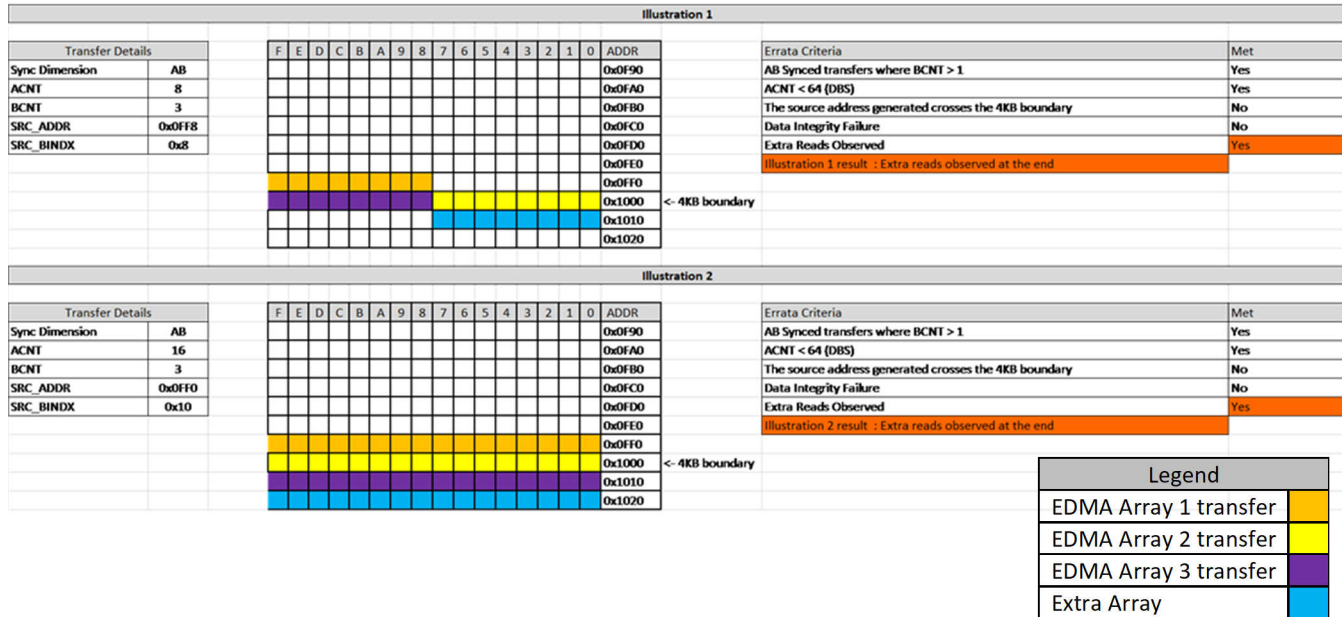
Figure 5-3. Scenario ID #5 – Extra Reads

For the extra read **Scenario ID #5** in for which **Condition [2]** is applicable, there is an extra read from starting address SRC + BCNT * ACNT (=SRCBIDX) of length equal to the distance of the start address and is of length ACNT.

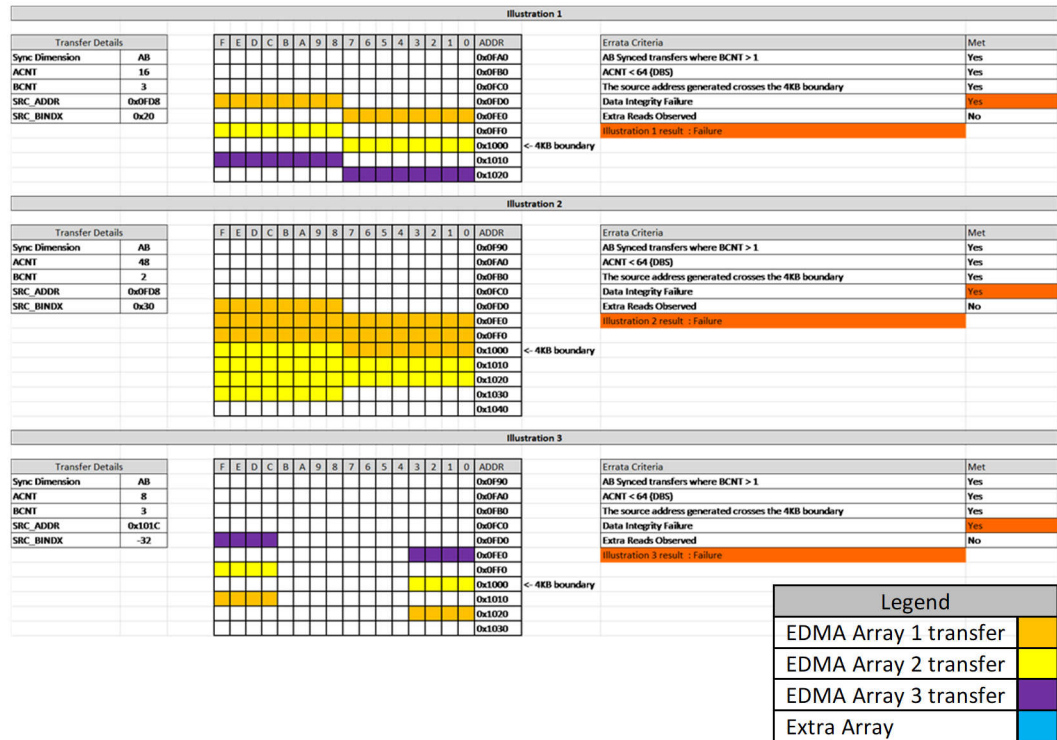
Figure 5-4. Scenario ID #1 – Data Integrity Failure

SCENARIO ID	CONDITIONS	DATA INTEGRITY FAILURES	HANGS	EXTRA READS
1	AB-sync BCNT > 1 ACNT not in [2,4,8,16,32] (ACNT < 64) OR ((ACNT = 64) AND (SRCBIDX != ACNT)) Source Addressing crossing 4-KB boundary for any of the BCNT number of ACNT transfers.	Yes (see Figure 5-4)	Possible	Possible
2	AB-sync with BCNT=1 or A-sync ACNT not in [2..24, 32] ACNT <= 64 Source Addressing crossing 4-KB boundary for any of the BCNT number of ACNT transfers.	No	Possible	Yes
3	AB-sync with BCNT=1 or A-sync ACNT in [2..24, 32] Source Addressing crossing 4-KB boundary for any of the BCNT number of ACNT transfers.	No	No	Yes (see Figure 5-1)
4	AB-sync BCNT > 1 ACNT in [2,4,8,16,32] SRCBIDX = ACNT ACNT * BCNT <=64 Source Addressing crossing 4-KB boundary for any of the BCNT number of ACNT transfers.	No	No	Yes (see Figure 5-2)
5	AB-sync BCNT > 1 ACNT in [2,4,8,16,32] SRCBIDX = ACNT ACNT * BCNT <=64 Source Addressing <i>does NOT</i> cross 4-KB boundary for any of the BCNT number of ACNT transfers; that is, NOT of Source Addressing crosses 4-KB boundary for merged source array of size ACNT * BCNT.	No	No	Yes (see Figure 5-3)

Prevent one or more of the conditions necessary for the problematic scenarios to happen.

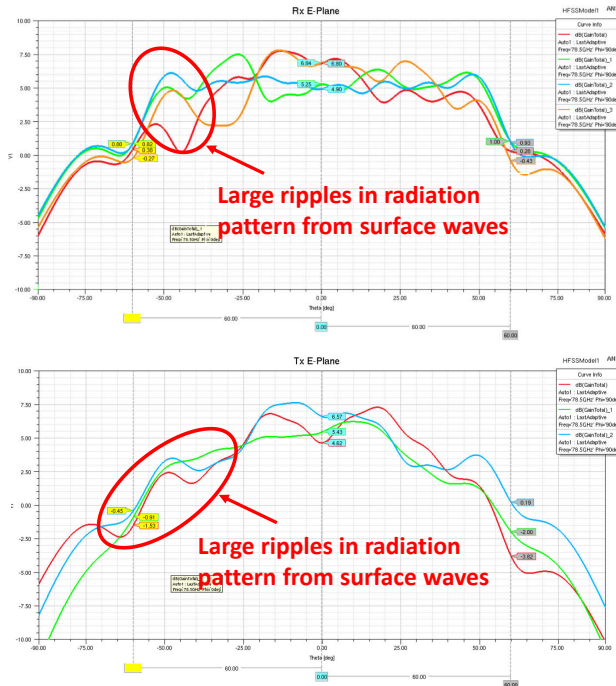
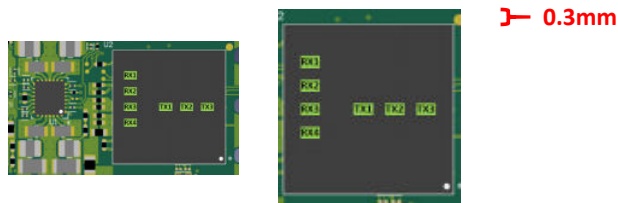
Figure 5-5. Small form factor board with PCB edge less than 0.3mm

Description: Large PCBs area around the E-plane causes surface waves that create large ripples in the elevation direction of the AoP antenna radiation pattern.

Keep the Edge of PCB close to the edge of the AoP device in the E-plane to minimize the surface wave ripples.
