TMS320F2807x Real-Time MCUs Silicon Errata

Silicon Revisions C, B

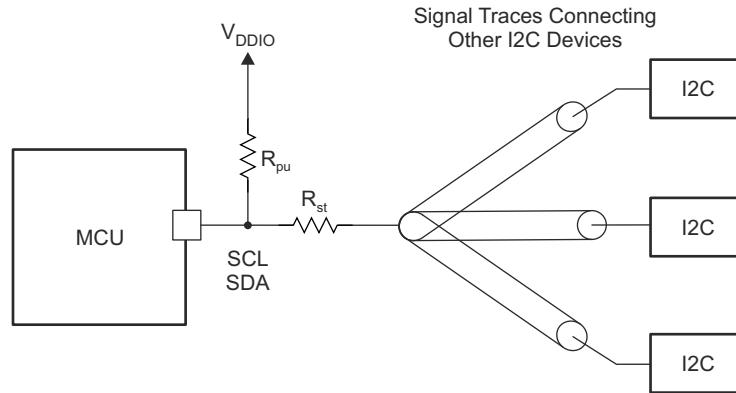
Figure 3-4. Placement of Series Termination Resistor and Pullup Resistor

The SDA and SCL outputs are implemented with push-pull 3-state output buffers rather than open-drain output buffers as required by I2C. While it is possible for the push-pull 3-state output buffers to behave as open-drain outputs, an internal timing skew issue causes the outputs to drive a logic-high for a duration of 0–5 ns before the outputs are disabled. The unexpected high-level pulse will only occur when the SCL or SDA outputs transition from a driven low state to a high-impedance state and there is sufficient internal timing skew on the respective I2C output.

This short high-level pulse injects energy in the I2C signals traces, which causes the I2C signals to sustain a period of ringing as a result of multiple transmission line reflections. This ringing should not cause an issue on the SDA signal because it only occurs at times when SDA is expected to be changing logic levels and the ringing will have time to damp before data is latched by the receiving device. The ringing may have enough amplitude to cross the SCL input buffer switching threshold several times during the first few nanoseconds of this ringing period, which may cause clock glitches. This ringing should not cause a problem if the amplitude is damped within the first 50 ns because I2C devices are required to filter their SCL inputs to remove clock glitches. Therefore, it is important to design the PCB signal traces to limit the duration of the ringing to less than 50 ns. One possible solution is to insert series termination resistors near the SCL and SDA terminals to attenuate transmission line reflections.

This issue may also cause the SDA output to be in contention with the slave SDA output for the duration of the unexpected high-level pulse when the slave begins its ACK cycle. This occurs because the slave may already be driving SDA low before the unexpected high-level pulse occurs. The glitch that occurs on SDA as a result of this short period of contention does not cause any I2C protocol issue but the peak current applies unwanted stress to both I2C devices and potentially increases power supply noise. Therefore, a series termination resistor located near the respective SDA terminal is required to limit the current during the short period of contention.

Insert series termination resistors on the SCL and SDA signals and locate them near the SCL and SDA terminals. The SCL and SDA pullup resistors should also be located near the SCL and SDA terminals. The placement of the series termination resistor and pullup resistor should be connected as shown in [Figure 3-4](#).

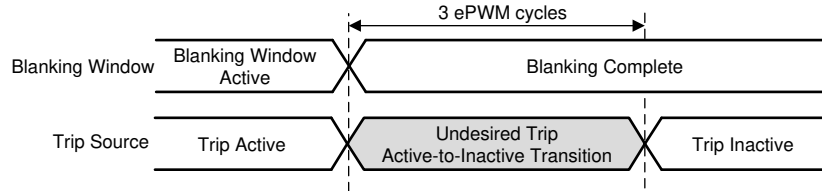
Figure 3-5. Undesired Trip Event and Blanking Window Expiration

The blanking window is typically used to mask any PWM trip events during transitions which would be false trips to the system. If an ePWM trip event remains active for less than three ePWM clocks after the end of the blanking window cycles, there can be an undesired glitch at the ePWM output.

Figure 3-5 illustrates the time period which could result in an undesired ePWM output.

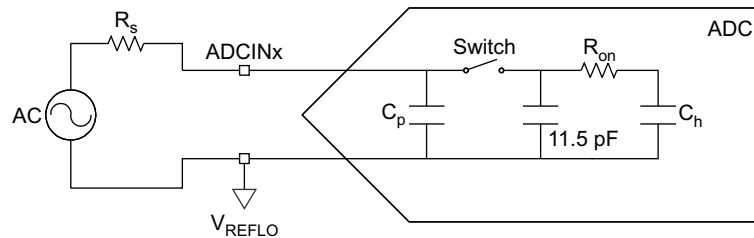
Figure 4-1. Single-Ended Input Model

The ADC input model should be used to select the sample-and-hold (S+H) duration for each ADC input. For the revisions affected, if the currently converting channel is an even-numbered channel and the previously converted channel was an odd-numbered channel (or vice versa), then the 12-bit input model will not accurately predict ADC input performance. Under these conditions, an additional capacitance should be added to the model. This capacitance has a value of 11.5 pF and should be placed between the S+H switch and R_{on} as shown in [Figure 4-1](#).
