CC1100 Silicon Errata

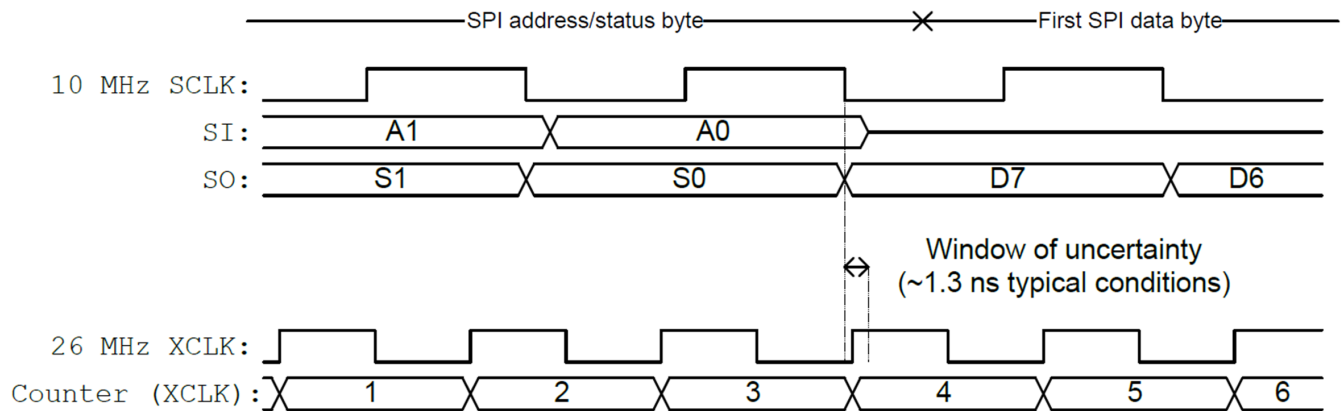
Figure 1. Window of Uncertainty (drawing not to scale)

Due to this synchronization issue, if the register being read changes value (synchronously with XCLK) during a certain period of time after this falling edge of SCLK then some of the bits in the read value will come from the **previous** value and some from the **next** value. This so-called window of uncertainty is about 1.3 ns for typical conditions and increases to about 2.0 ns for worst-case conditions (1.8 V VDD, 85 °C).

Figure 1 shows a timing diagram of an SPI read that fails when reading a fictitious counter being updated internally each XCLK. Since the counter update from value 3 (011b) to 4 (100b) within the window of uncertainty, the read value could be any one of 0-7 (000b, 001b, 010b, 011b, 100b, 101b, 110b, 111b) depending on exactly when the positive edge of XCLK falls within the window of uncertainty.

If it is important to ensure that read values are not corrupted, reading of one of the affected registers should be done repeatedly until the same value is read twice in succession. If the rate at which the register is read is specified to be at least twice as fast as the expected register update rate, then an upper bound on the number of required reads is four and the average number of reads slightly more than two.
